BAB SHAMS POLICE STATION  
MOSUL, IRAQ

SUSTAINMENT ASSESSMENT

**SIGIR PA-06-091**  
**APRIL 25, 2007**

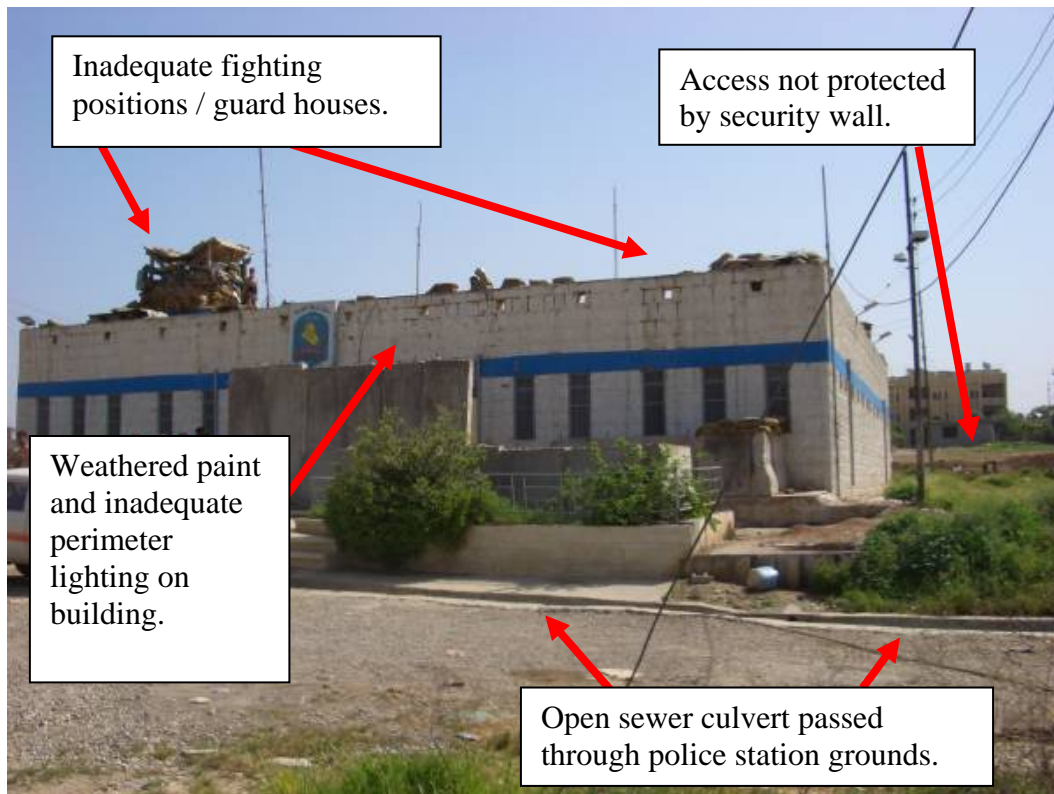
**USACE Pre-Construction Photo 1.**

As an overview of general requirements, USACE Pre-Construction Photo 1 documented several pre-existing conditions that needed to be addressed in the renovation project. For example, an open sewer, shown in USACE Pre-Construction Photo 2, passed near the front of the station; the building and grounds were not protected by a solid material security wall, building perimeter security lighting was inadequate, exterior paint was severely weathered, and rooftop fighting positions were inadequate. The subsequent status of all of the aforementioned pre-existing conditions are described and/or shown more clearly via photos taken by USACE officials during construction or by SIGIR inspectors while on site on 28 January 2007. Significant issues relating to the (1) open sewer, (2) electrical system improvements, and (3) construction of the security wall are discussed in detail later in this report.

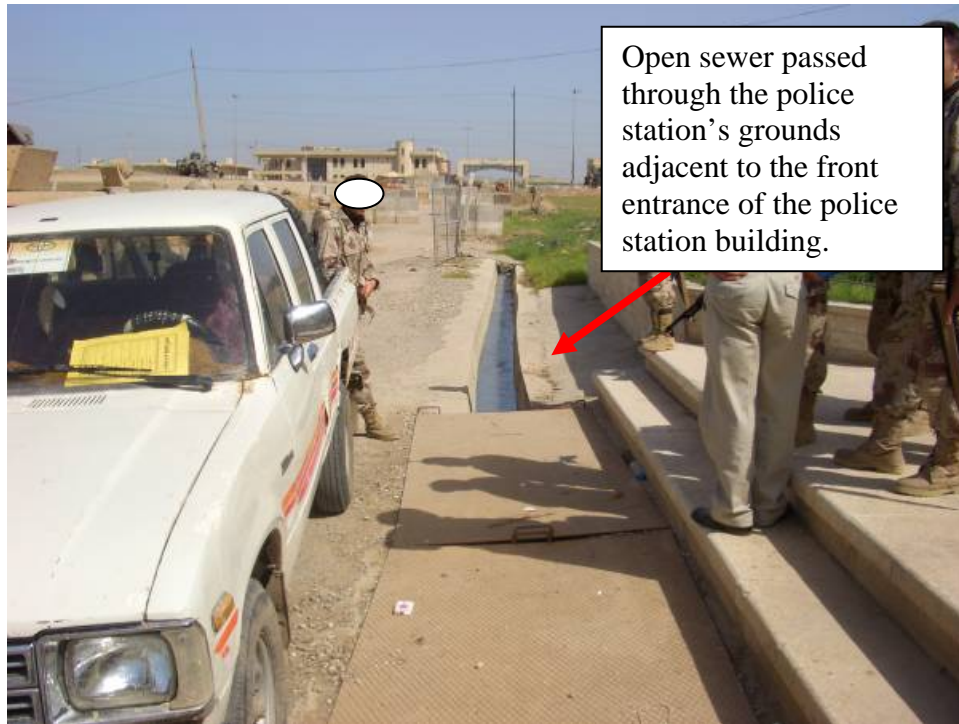
**USACE Pre-Construction Photo 2.**

Open sewer passed through the police station's grounds adjacent to the front entrance of the police station building.

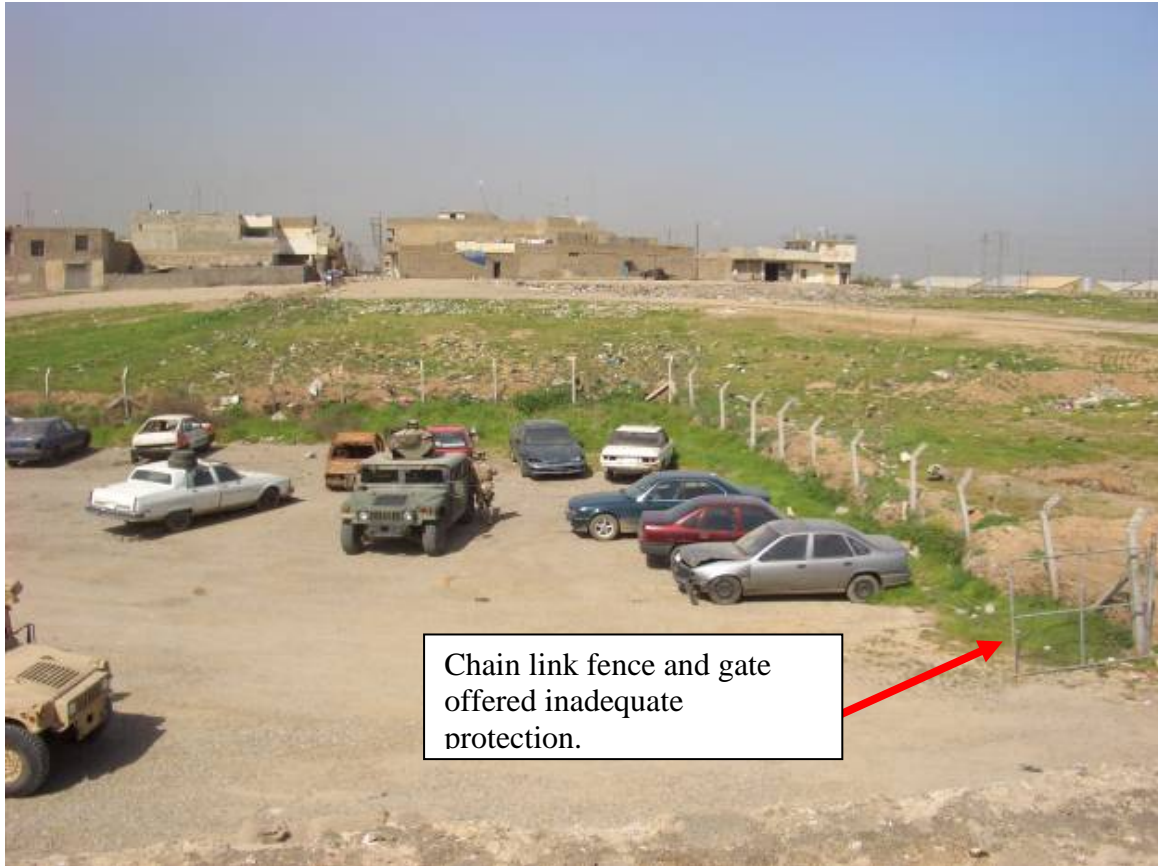
Prior to construction, the facility was minimally protected by a chain link fence and gate system that offered virtually no cover or concealment if the facility came under attack<sup>2</sup>. It appeared the fence and gate could be easily breached by vehicles or personnel (USACE Pre-Construction Photo 3). In addition, encroachment avenues for vehicles and personnel were accessible to all four sides of the facility and grounds. To correct these critical pre-existing deficiencies, the SOW included requirements to build a solid block security wall with a heavy metal gate.

**USACE Pre-Construction Photo 3. Without a solid block wall, police station was vulnerable to direct fire and tactical observation from nearby buildings and open fields.**

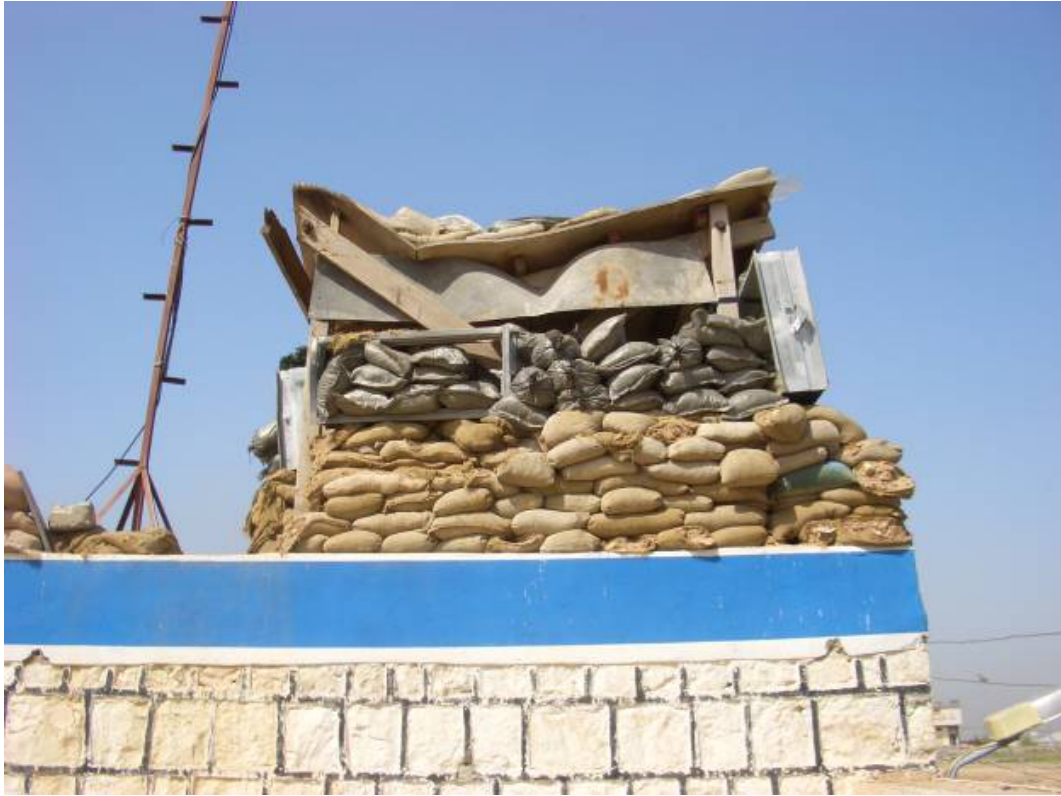
Pre-existing rooftop fighting positions and guard houses were constructed in a crude and non-uniform manner. Some positions did not have overhead cover and were nothing more than a makeshift berm made of sand bags (USACE Pre-Construction Photo 5). Another corner position included overhead protection, but fields of fire were very likely too narrow to provided sufficient defensive coverage because field of vision was constrained. Accordingly, the contract's SOW required the contractor to build a suitable fighting position/guard house at each corner of the police station building.

**USACE Pre-Construction Photo 5. Rooftop fighting positions/guard houses before renovation.**

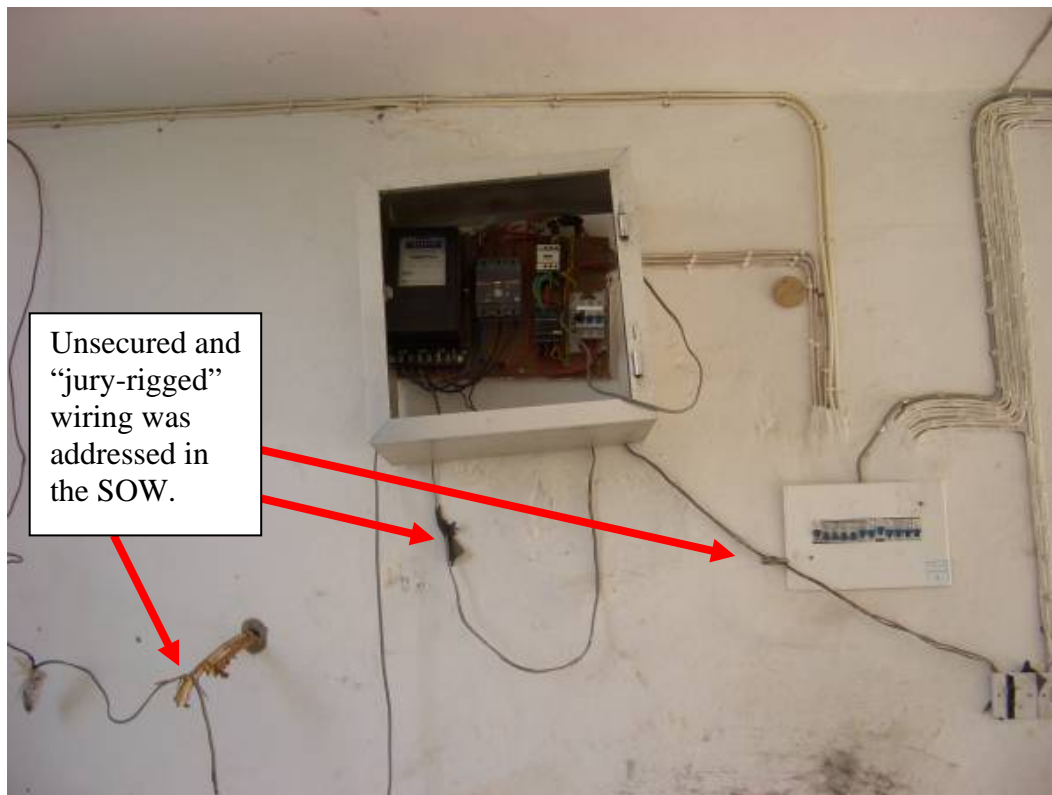
**USACE Pre-Construction Photo 6.**

The SOW specified that the pre-existing electrical system needed to be significantly upgraded during renovation. The contractor was required to repair exposed wiring, add wiring/circuits, switches, plug-ins, fluorescent lighting ballasts, building perimeter lighting, and other electrical upgrades. In addition, the SOW included a requirement to securely attach all wiring to walls. An example of the pre-existing condition of the electrical system is shown in USACE Pre-Construction Photo 6. The photo shows “jury-rigged” and unsecured wiring.

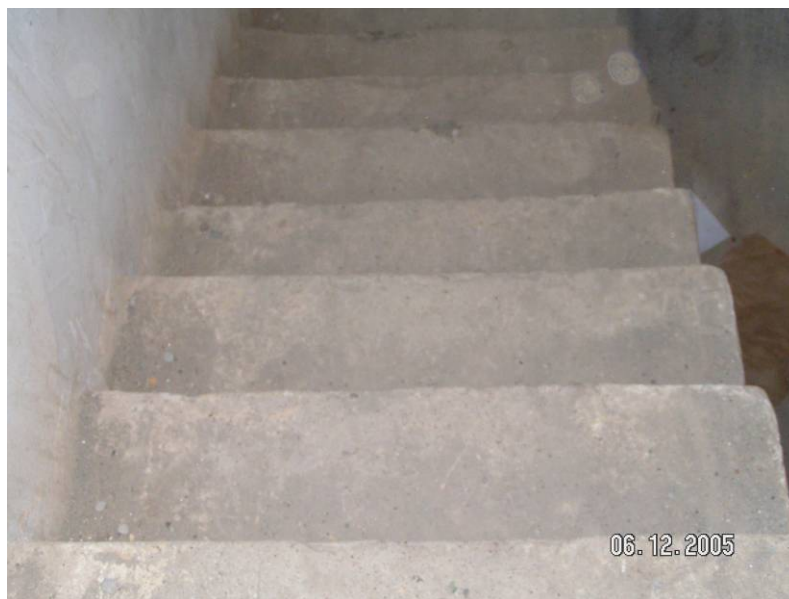
**USACE Pre-Construction Photo 8. Before renovation, steps were bare, unsealed concrete.**

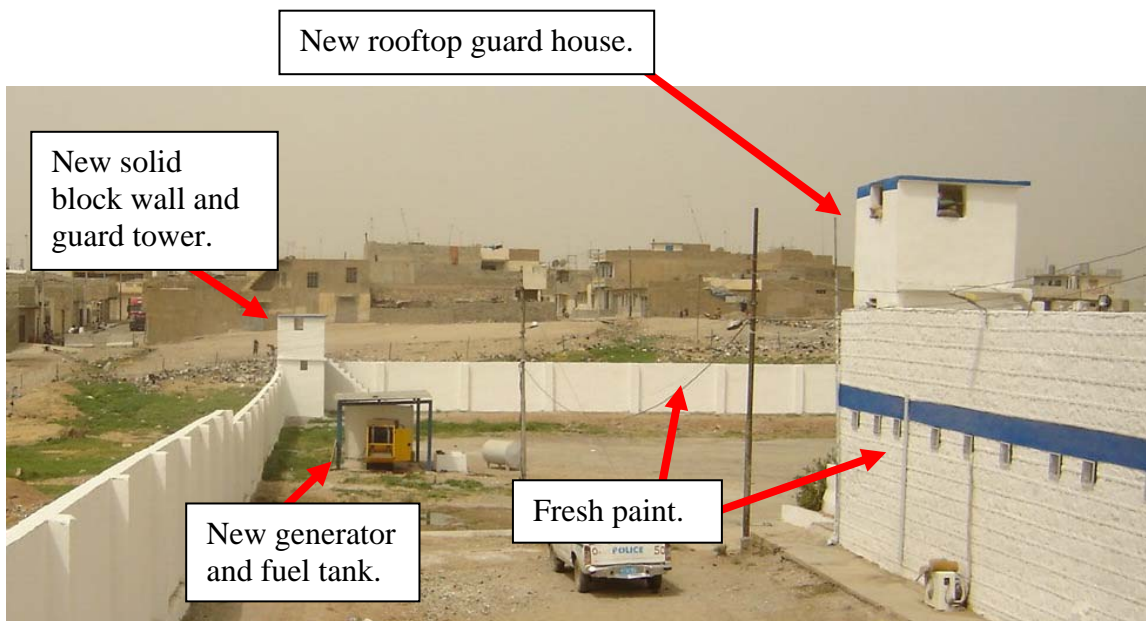
USACE Construction Photo 1 (12 Aug 05)

USACE Construction Photo 1 shows five high value requirements: generator system (\$79,000), painting (\$58,800), rooftop guard houses (\$18,000), solid block security wall (\$120,000) and guard towers (\$22,000). All were very likely constructed or installed in accordance with contract requirements. When combined, the aforementioned high value requirement totaled \$297,800 or approximately 84% of the contract's total value of \$353,400.

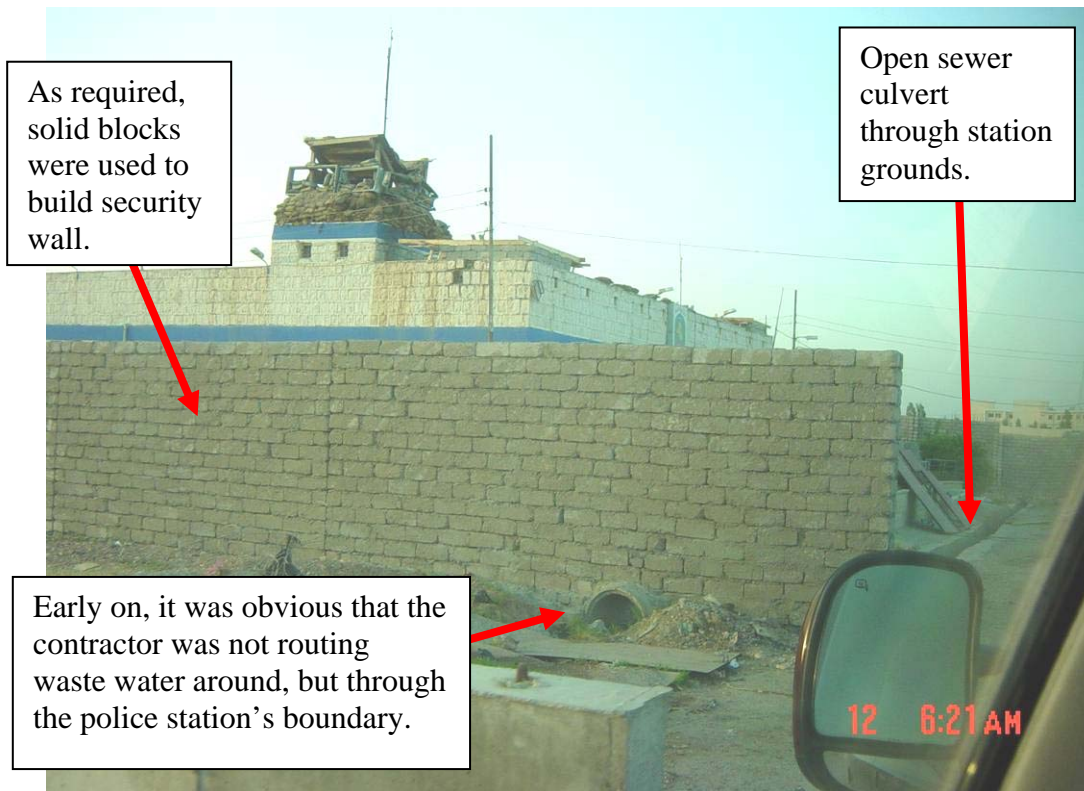
USACE Construction Photo 2 (12 Jun 05)

Contrary to SOW requirements, USACE Construction Photos 2 and 3 show that sewer water was not being routed around the perimeter of the police station, but through the station's boundaries. Issues related to the location of the sewer water conveyance system are addressed in the Site Assessment section of this report.

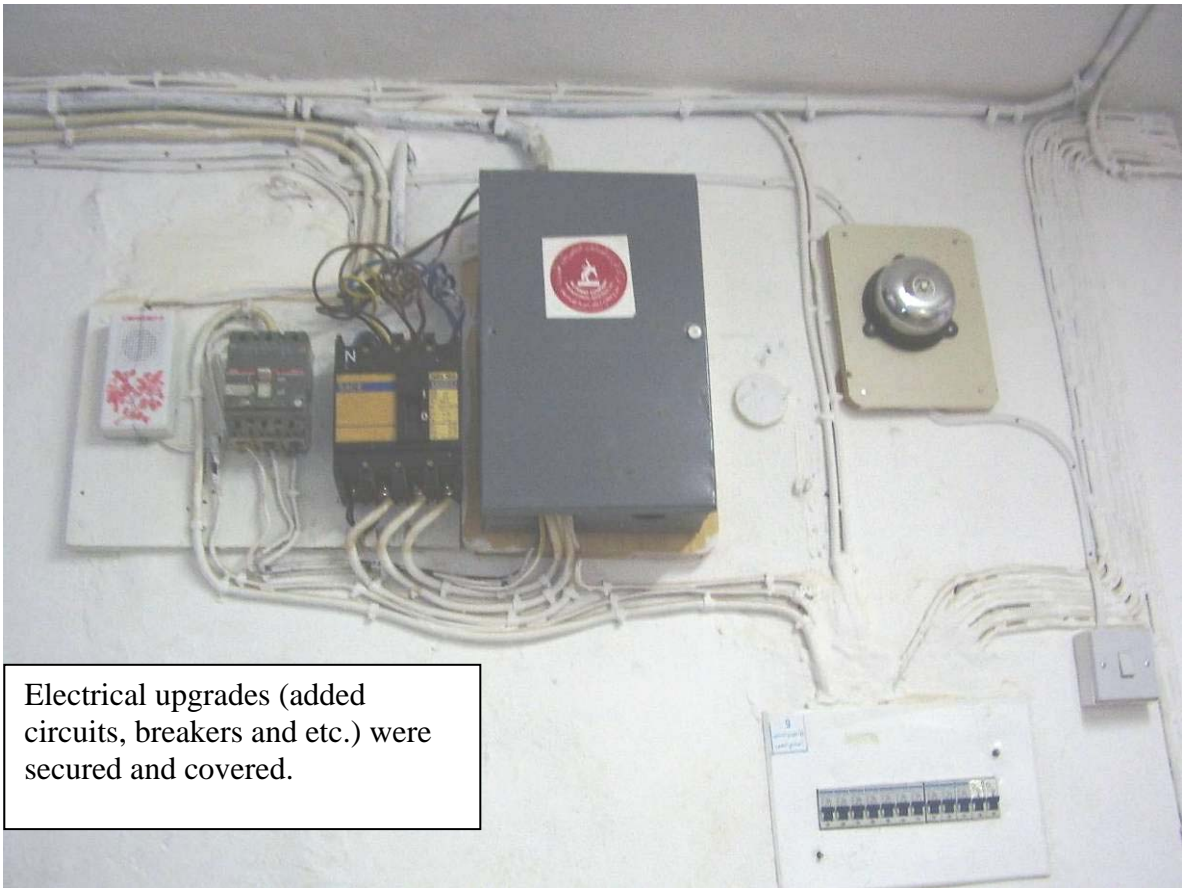
**USACE Construction Photo 5 (23 Sep 05)**

While USACE Pre-Construction Photo 6 documented that damaged, exposed, and unsecured wiring was present before renovation, USACE Construction Photo 5 shows that the pre-construction conditions were corrected by the contractor during the renovation project. In short, USACE Pre-Construction Photo 5 and USACE Construction Photo 6 document a "before and after" comparison of an electrical box and wiring at the same location within the building. USACE Construction Photo 6 shows a circuit breaker box that was properly covered and free of tampering following renovation. Other photos taken during construction by USACE personnel show examples of work properly completed by the contractor. For example, USACE Construction Photo 7 shows that switches and plug-ins were installed, USACE Construction Photo 8 confirmed that wiring and electrical system components were securely fastened to walls, and USACE Construction Photo 9 shows where exterior lighting was installed on the building's perimeter. All of the aforementioned examples appeared to meet contract requirements.

Electrical upgrades (added circuits, breakers and etc.) were secured and covered.

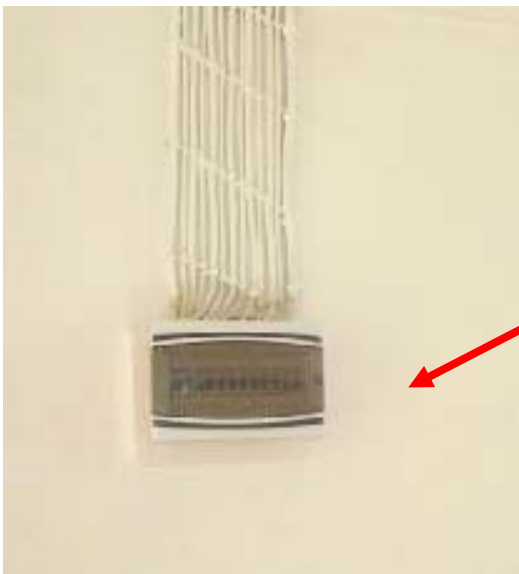
**USACE Construction Photo 6 (15 Aug 05)**

Breaker boxes were covered and free off tampering.

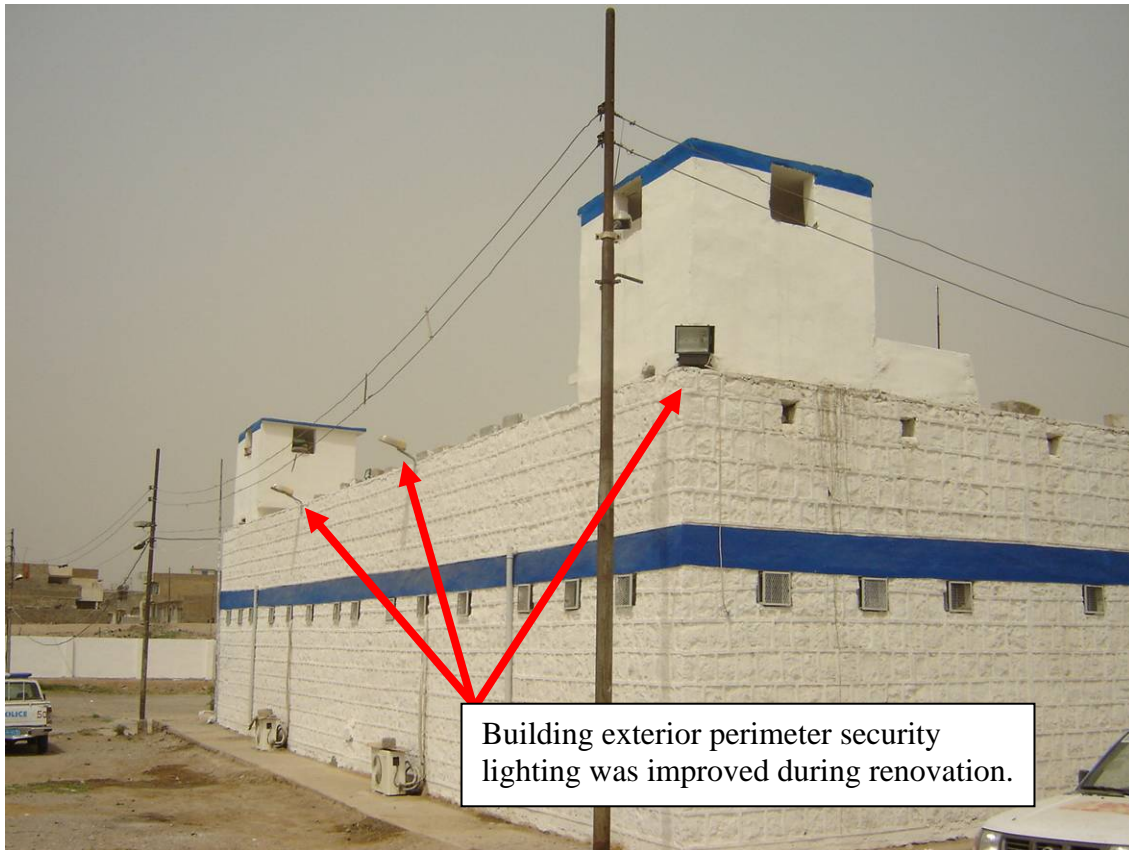
USACE Construction Photo 9 (11 Aug 05)

- USACE Construction Photo 9 shows that exterior lighting was installed by the contractor in accordance with SOW requirements. However, the lighting does not appear in Site Photo 18, which was taken at the same spot. SIGIR inspectors observed similar instances of missing lighting.

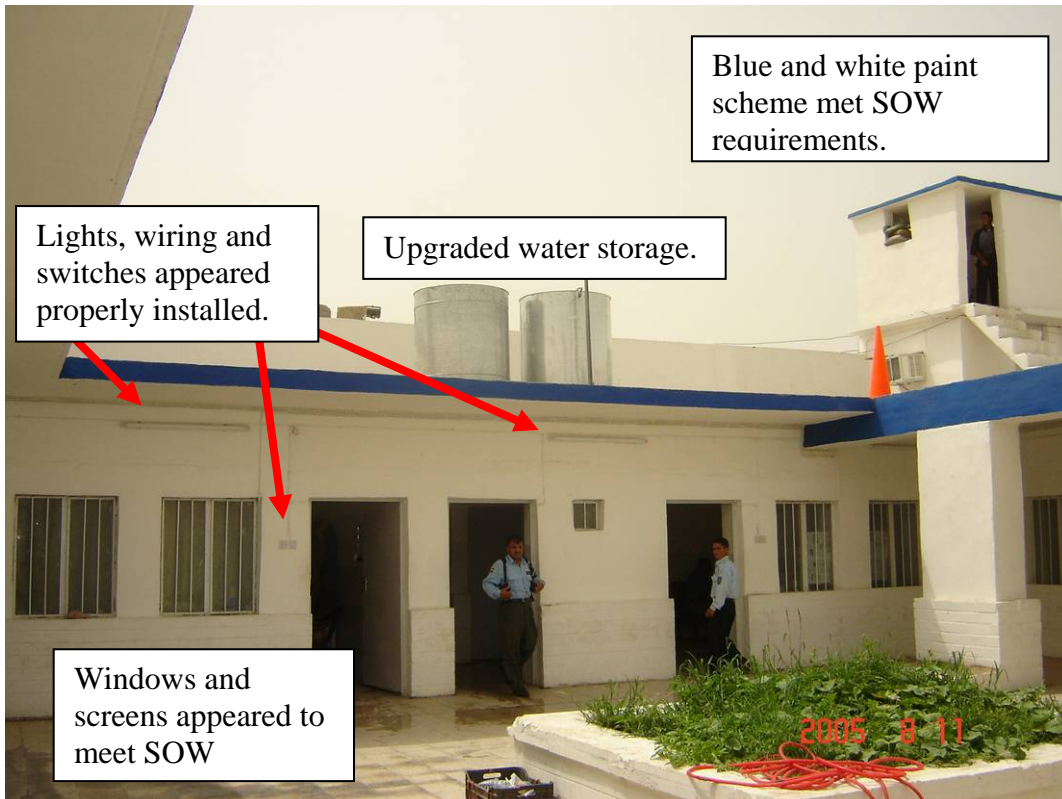
USACE Construction Photo 13 (11 Aug 05)

SIGIR inspectors used USACE Construction Photo 13 to present a general overview of the facilities' interior condition following renovation. The interior is that part of the facility inside the outside perimeter of the building and generally accessed from the courtyard area. In USACE Construction Photo 13, it appeared that windows, screens, and painting met SOW requirements. In addition, an upgraded water storage system can be seen in USACE Construction Photo 13.

Upgraded water storage.

Windows and screens appeared to meet SOW

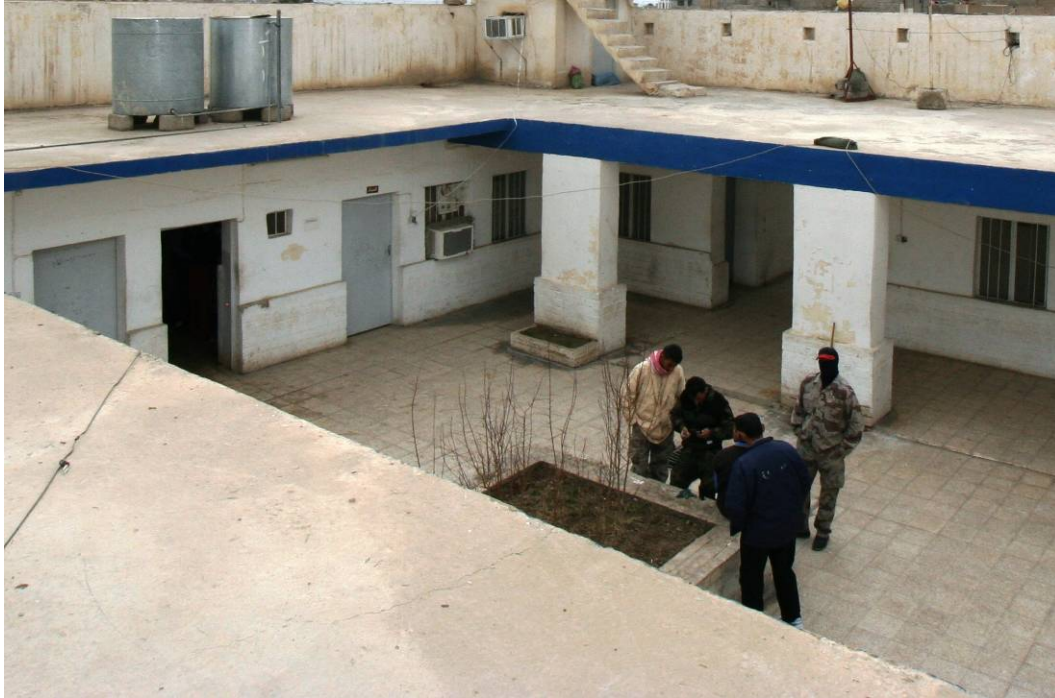
Most elements of the renovation project appeared to meet SOW requirements and the facility appeared to be able to operate at full capacity<sup>4</sup> when observed. Site Photo 1 confirmed that the same area shown in USACE Construction Photo 13 appeared to be or remained functional on 28 January 2007. Several toilets were flushed and several sinks were partially filled and drained to verify operability. In addition, the inspectors observed several sewer line traps and confirmed that they were open and that sewage generated within the police station building was able to flow. Site Photo 2 shows the specific traps observed by the inspectors. The area around the traps was dry and did not show evidence of routine plugging or backed-up sewage.

**Site Photo 1. Observed condition of the same general area shown in USACE Construction Photo 13 appeared functional.**

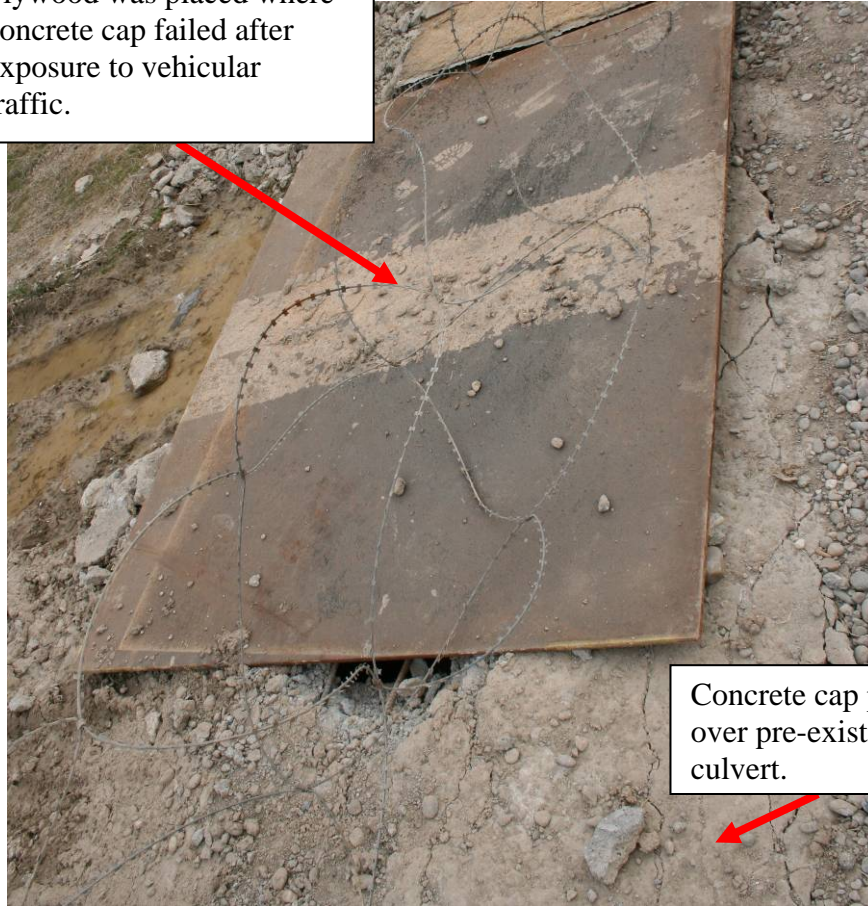
**Site Photo 3.**

Rather than route sewer water around the perimeter of the station, the contractor merely capped the pre-existing open culvert with concrete. SIGIR inspectors observed that the construction of the concrete cap was poor for a number of reasons and had collapsed under the weight of vehicle traffic (Site Photo 3). As shown in Site Photo 4, the concrete was not uniformly mixed, was cast too thin and was cast without rebar or wire to improve the tensile strength.

Plywood was placed where concrete cap failed after exposure to vehicular traffic.

Concrete cap placed over pre-existing open culvert.

USACE/IRMO should survey the site’s current condition and develop cost effective plans to (1) route waste water around the perimeter of the police station and (2) securely attach wire to the security perimeter wall.

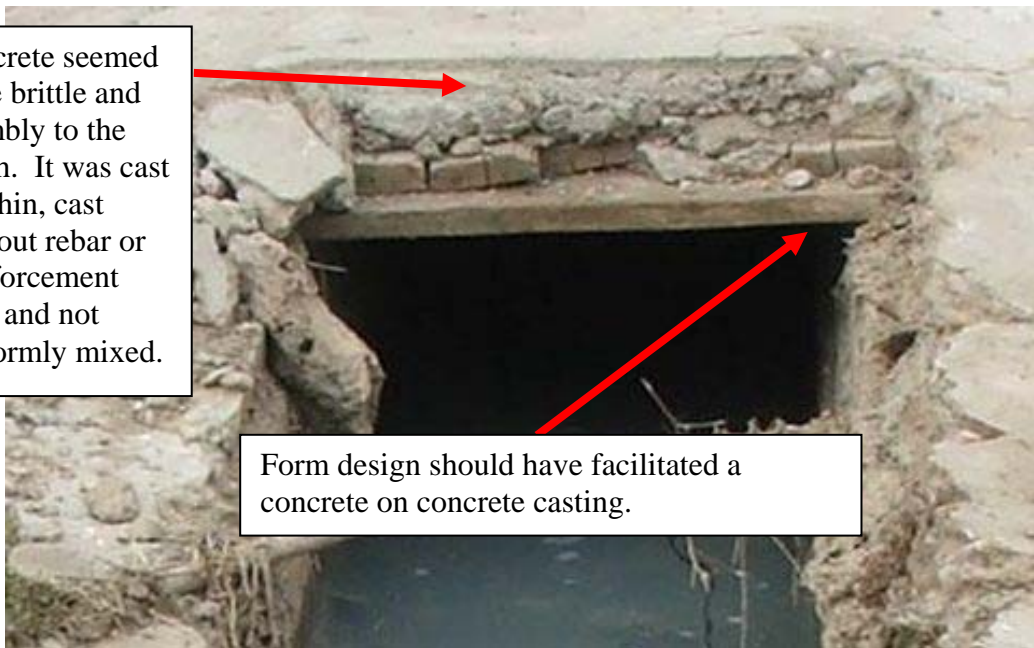
**Site Photo 4.**

In addition, forms should have been constructed in such a manner that the new concrete material would have been placed to touch the culvert's concrete side wall, which is concrete on concrete without wood between the new casting and the existing sidewall. The technique used by the contractor only increased the likelihood of concrete failure. As the wood rots, more stress is placed on the casting as it settles towards a concrete on concrete position.

Concrete seemed to be brittle and crumbly to the touch. It was cast too thin, cast without rebar or reinforcement wire and not uniformly mixed.

Form design should have facilitated a concrete on concrete casting.

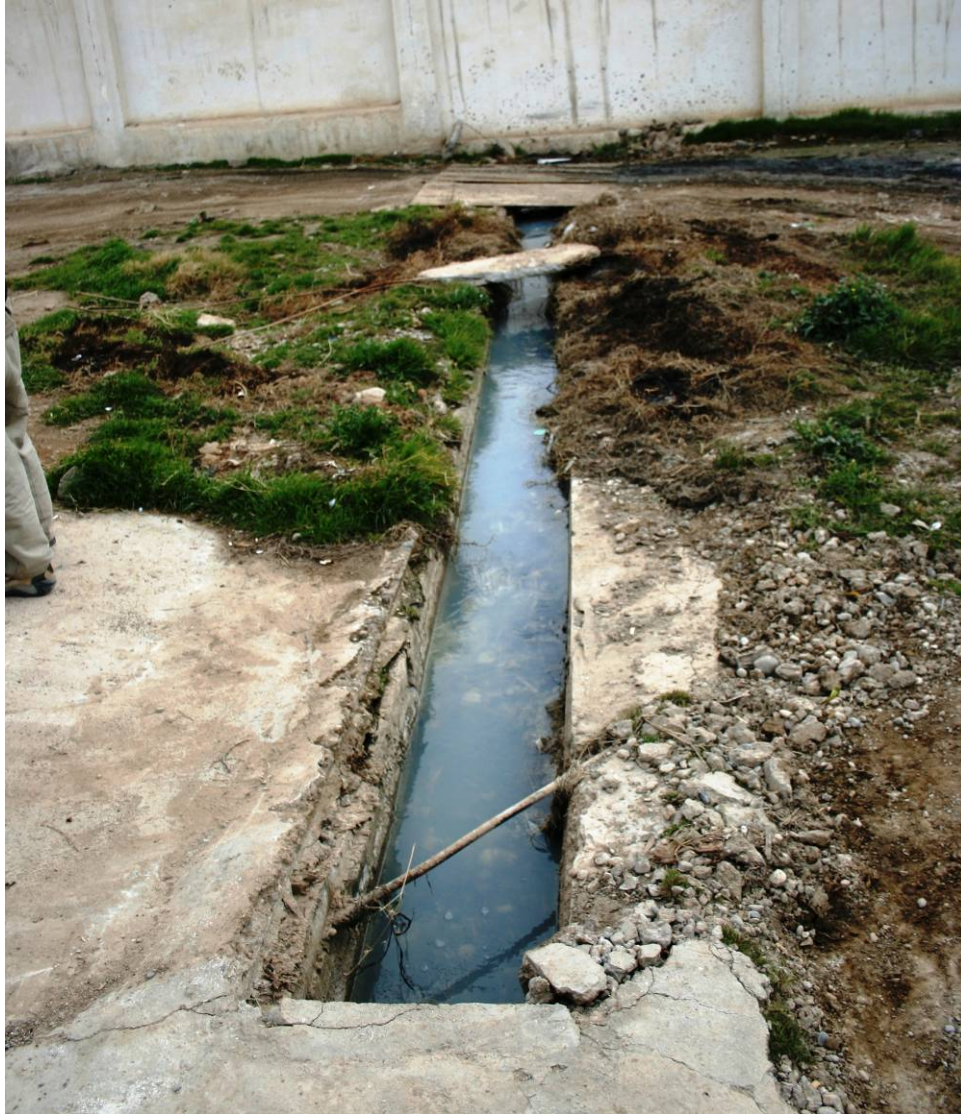
**Site Photo 5.**

Before renovation, the chain linked fence (USACE Pre-Construction Photo 3) that surrounded the IP station did not impede runoff water. Conversely, the new solid block security wall (USACE Construction Photo 3 and Site Photo 5) on the low<sup>5</sup> side of the compound could block or impede the flow of rain water runoff and sewage water flow (Site Photo 6). The runoff from within the compound, combined with the regular sewer water flow and rain water runoff channeled into the station from outside the compound, could lead to standing water conditions within the compound.

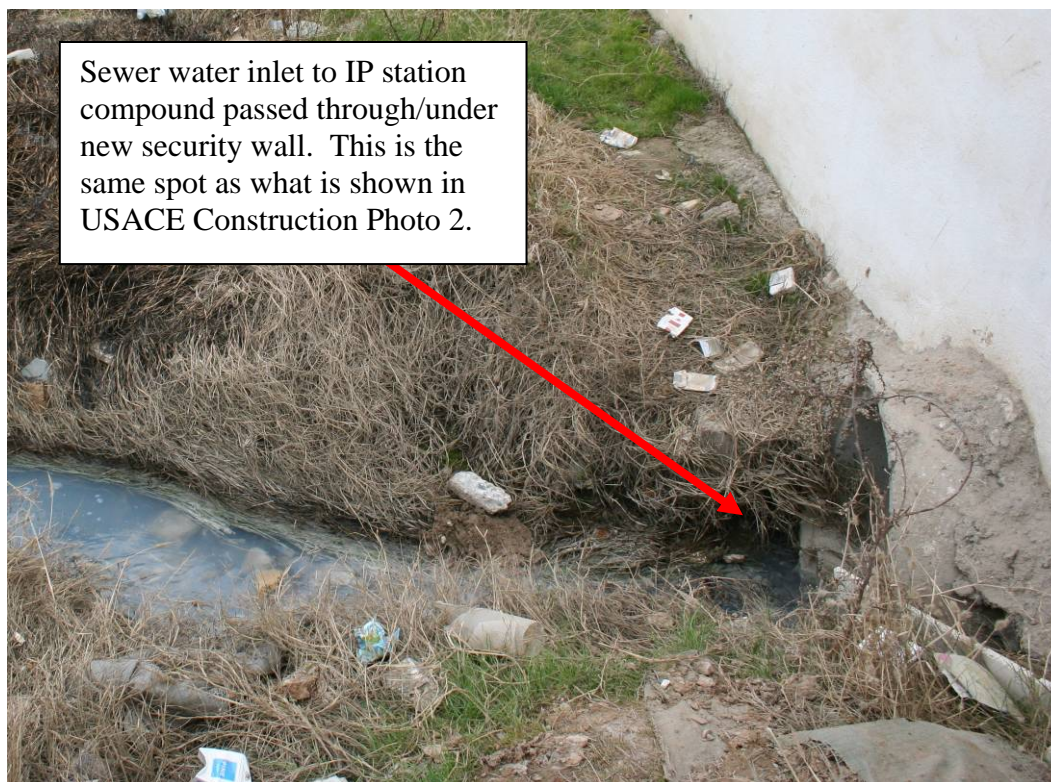
**Site Photo 7.**

At the time of the site inspection, the conditions were dry and not impacted by recent rains. Nevertheless, Site Photo 7 shows that the open culvert on the high side or half of the compound was running free and able to handle the waste water volume entering the compound that day. However, Site Photo 8 taken at the exit and the open culvert's lowest spot within the confines of the compound shows the open culvert nearly full. It would not take much rain water runoff to create a flooded condition within parts of the IP compound area.

Sewer water inlet to IP station compound passed through/under new security wall. This is the same spot as what is shown in USACE Construction Photo 2.

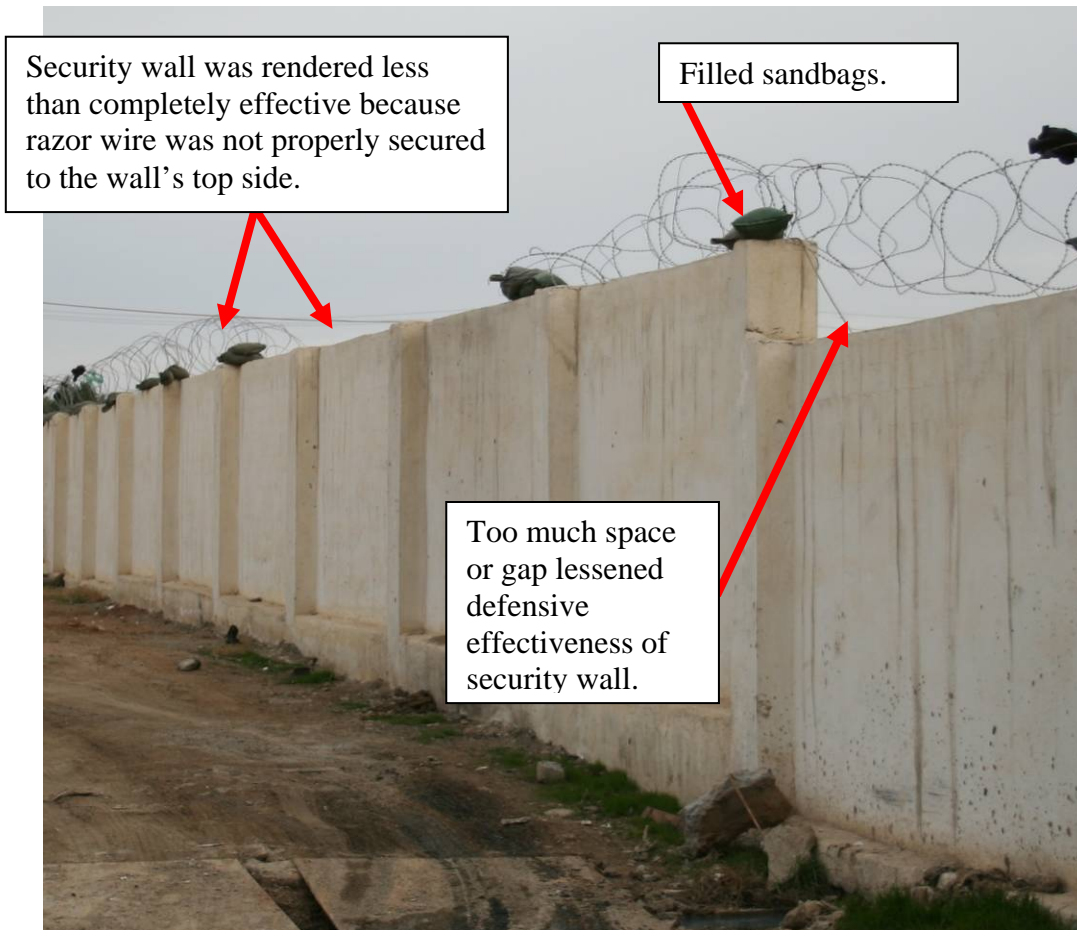
Site Photo 9.

All requirements related to the construction of the security wall were met with the exception of the barbwire which was not adequately secured and placed on the top side of the wall. Site Photo 9 shows that the wire was merely held in place by sand bags that could be pushed or pulled off by personnel wanting to scale the wall. Without the sand bags in place, the wire does not stay in place atop the wall. In addition, the wire was stretched in such a manner that spaces or gaps between the wire and wall developed. SIGIR inspectors observed several places where the wire was not attached or placed in a manner that enhanced the defensive effectiveness of the security wall.

A review of the USACE final inspection report dated 23 September 2005, disclosed that the wire for the top of the perimeter wall was not installed and was “still piled up on the ground where it was unloaded from the delivery truck”. USACE officials were aware of

the problem; however, it appeared that issues related to the wire were not adequately addressed before final payment to the contractor was approved by the USACE RE.

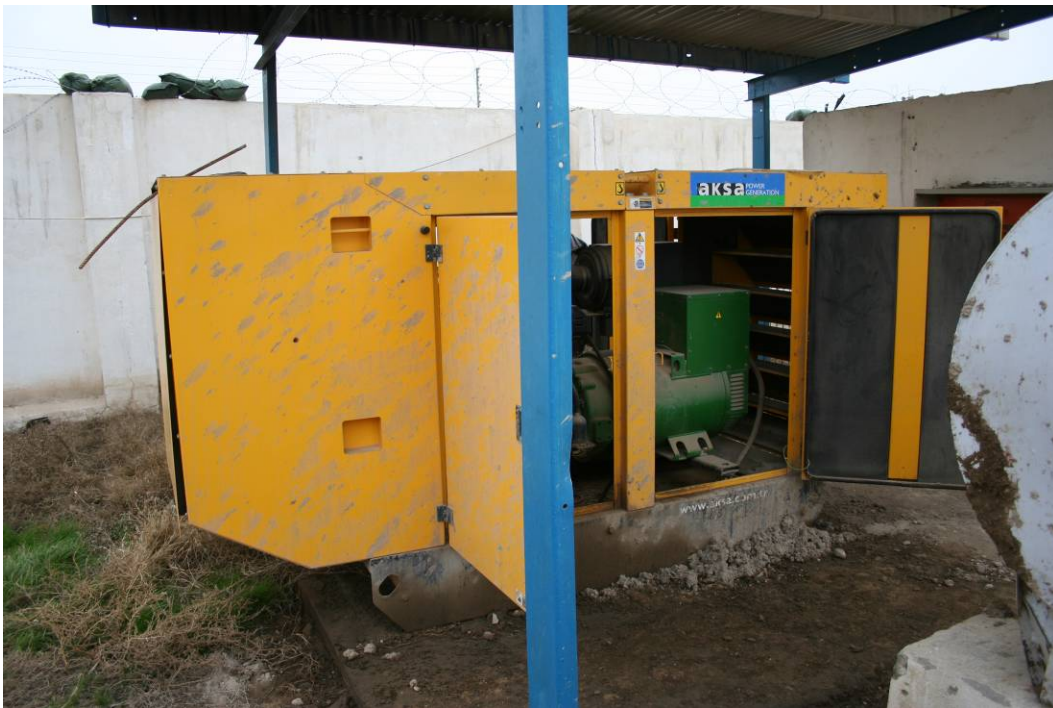
The new generator, which cost \$79,000, appeared to have been abandoned (Site Photo 11). Issues related to automatic transfer switch and controls will be addressed in the next section of this report.

**Site Photo 11. Without a fuel line and working controls, the new generator appeared abandoned.**

- Make the generator operational.
- Reinstall lighting, switches, and other electrical components that have been removed or damaged.
- Implement an effective equipment and facility O&M program staffed with trained personnel.
- Implement supervisory procedures to ensure that equipment and facilities are not misused and electrical components are not tampered with or removed.

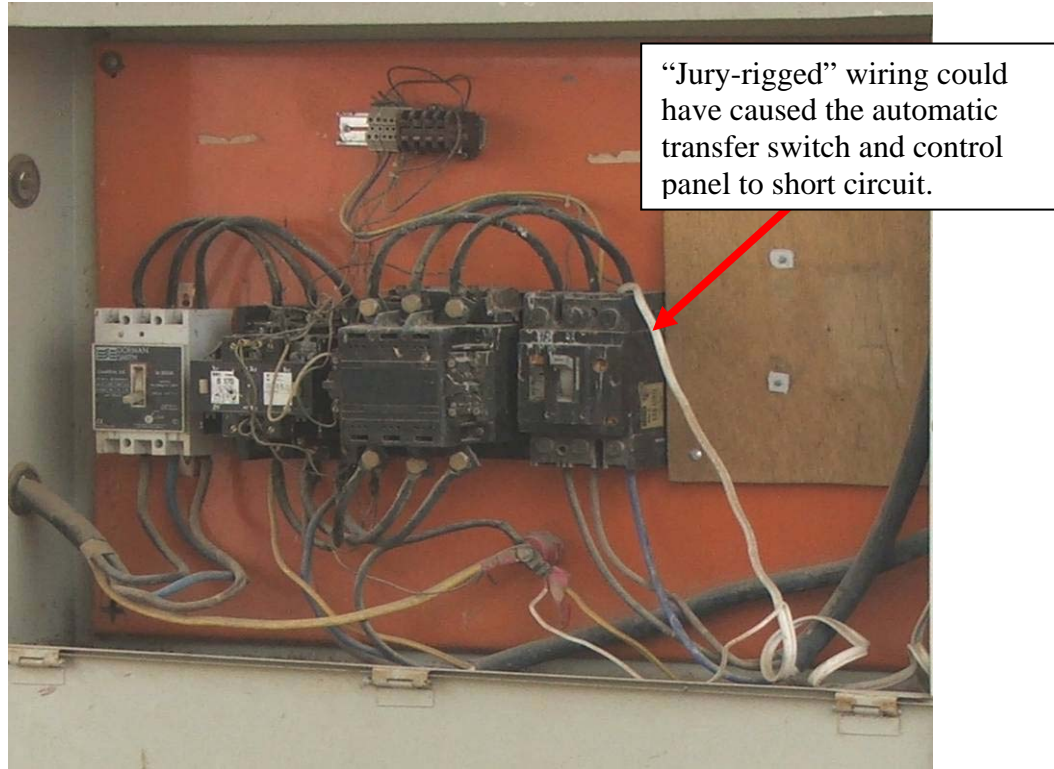
**Site Photo 12.**

SIGIR inspectors observed that the automatic transfer switch and control panel had been tampered with and that the door on the automatic transfer switch and controls panel was wide open and the expensive switching components were exposed. While the inspectors were told by IP personnel that the transfer switches were broken, we could not determine when or by whom the “jury-rigged” wiring was added to the circuitry (SIGIR Site Photo 12). In any case, “jury-rigged” wiring likely could have caused the automatic transfer switch and control panel components to short circuit and break down.

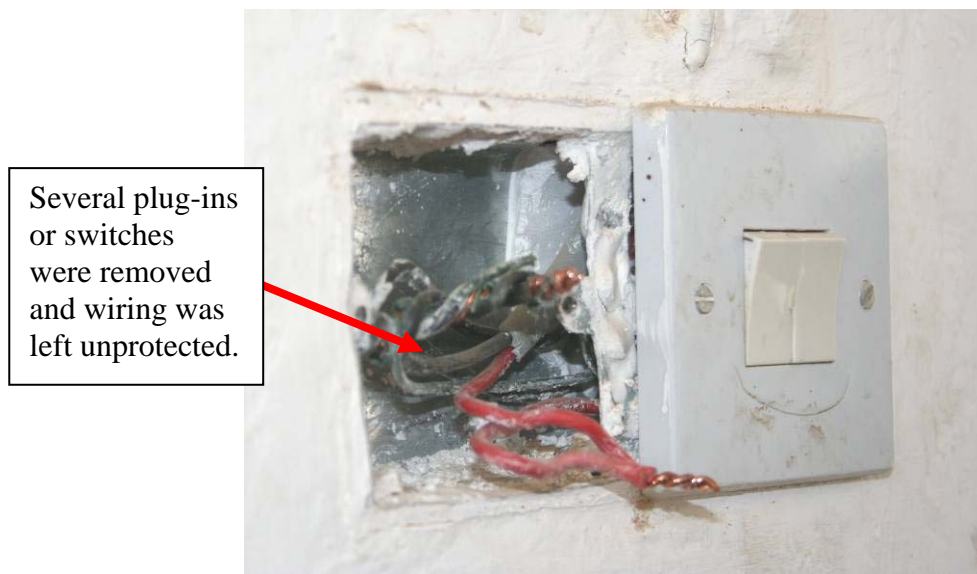
**Site Photo 13.**

Throughout the facility, SIGIR inspectors observed that numerous switches or plug-ins had been removed. In every case of a missing switch or plug-in, the wiring was crudely twisted together in order to keep the circuit closed as a means to allow power to flow to draw points (lights, switches, plug-ins, etc.) farther down the circuit. SIGIR Site Photo 13 is an example of one of several places where a switch or plug-in was removed.

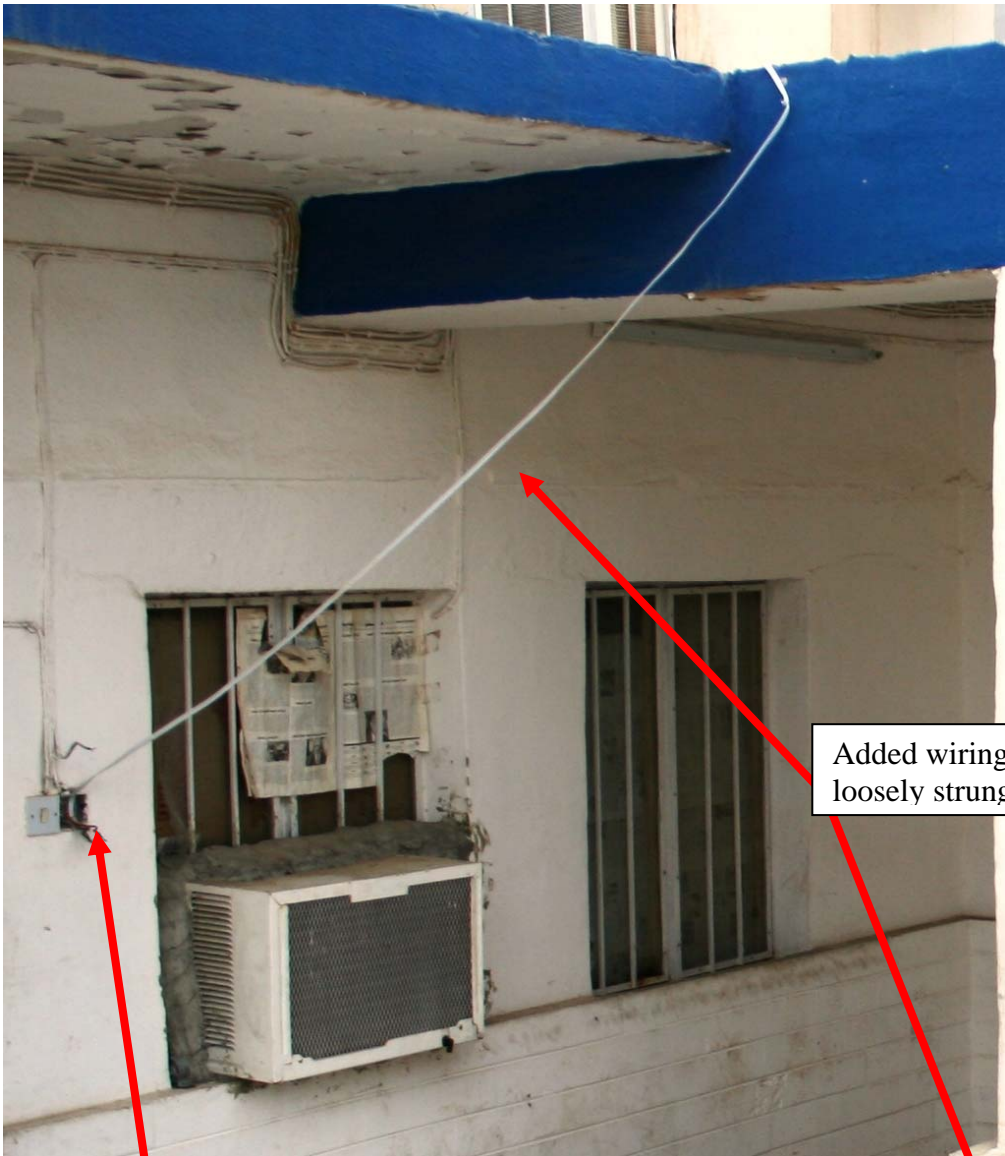
**Site Photo 14.**

In Site Photos 14 and 15 a typical form of tampering observed by SIGIR inspectors is shown. Site Photo 14 shows how added wiring was loosely strung. Site Photo 15 is a close up and it shows the technique used to “tap into” an existing circuit. Specifically, the existing circuit and load requirement was maintained by twisting the wiring together in order to close the existing circuit. However, the “jury-rigged” wiring that fed a draw point only added to the circuit’s potential load or draw.

Switch or plug-in was removed and added wiring "tapped into" the circuitry.
